Civil Works Hydropower R&D Program

Cavitation-Resistant Coatings for Hydropower Turbines

Ryan Sollars and Alfred D. Beitelman

June 2011

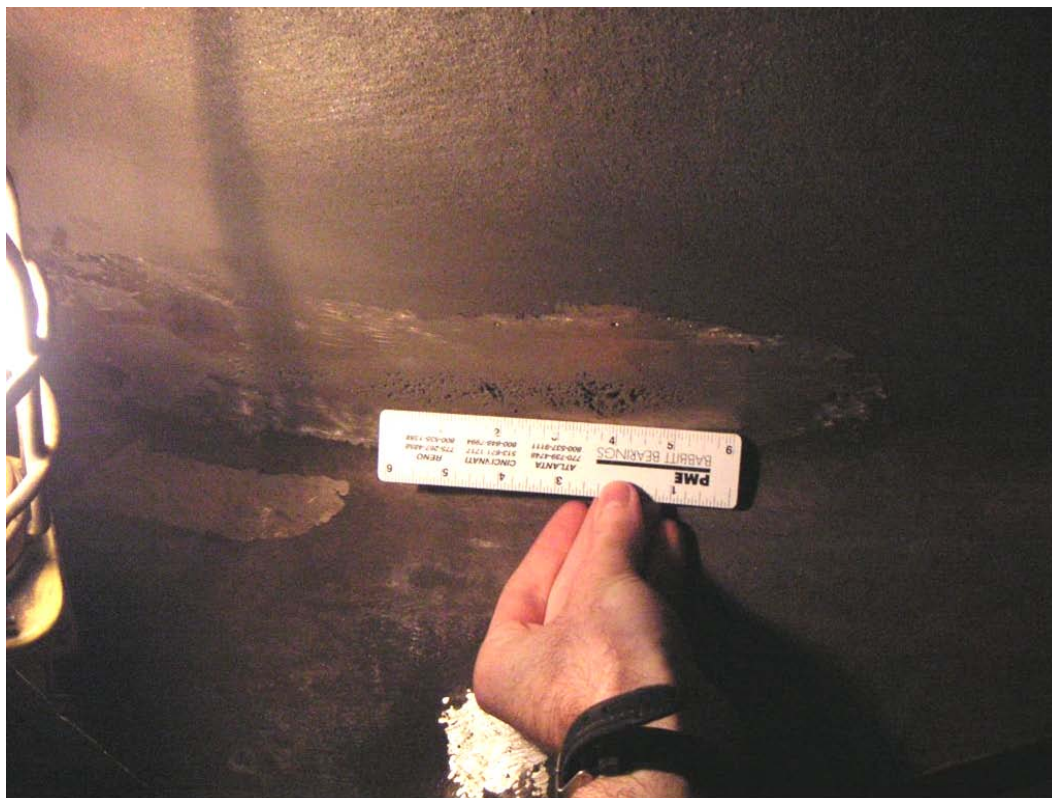
RUNNER DISCHARGE SIDE AT BAND: Cavitation was present on every bucket, on the fillet between the bucket and the band. The area and extent of the damage was approximately the same in all locations.

Figure 1. Typical cavitation damage areas on lower one-third of suction side of buckets after approximately 1 year of operation since last repair.

Prior to application of the coatings, the existing cavitation was repaired on each of the test buckets. The base metal of the runner is cast steel, QQ-5-681, class 3. The repair conducted by site personnel consisted of fill welding the area with 309 stainless and grinding the repair smooth. The coating applicator Flame Spray Incorporated (FSI) then abrasive blasted the surfaces with aluminum oxide grit. The surface roughness of the substrate before coating as well as that of the applied coating was recorded and documented by FSI (see Appendix A). The sketches in this appendix show the average roughness (Ra) in microinches (1000 μ in. is equivalent to 1 mil or 0.001 in.). The sketches include a line indicating the direction the instrument was oriented while making the reading. The sketches also show the location of a number of spots indicating cavities remaining in the surface after the grinding and abrasive blasting. Such cavities are inevitable. Some of the larger holes show an estimated diameter (\emptyset) and depth (\downarrow) in inches; however, the majority of the holes that are shown simply as spots were too small to accurately estimate.

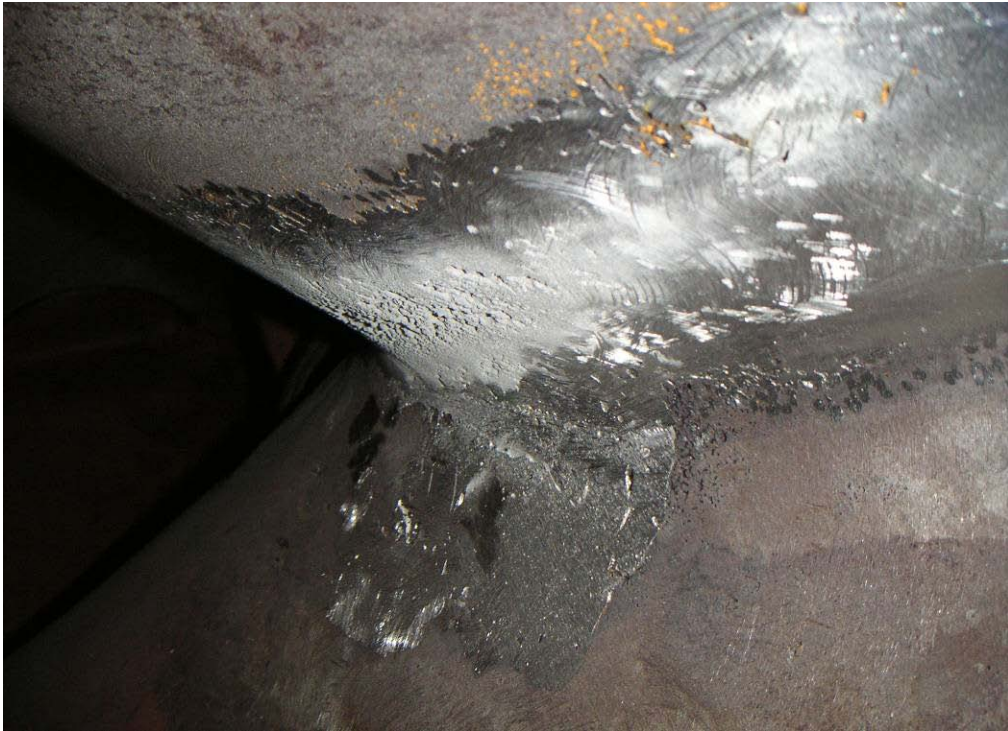
Figure 2. Typical cavitation damage areas on upper one-third of suction side of buckets after approximately 1 year of operation since last repair.

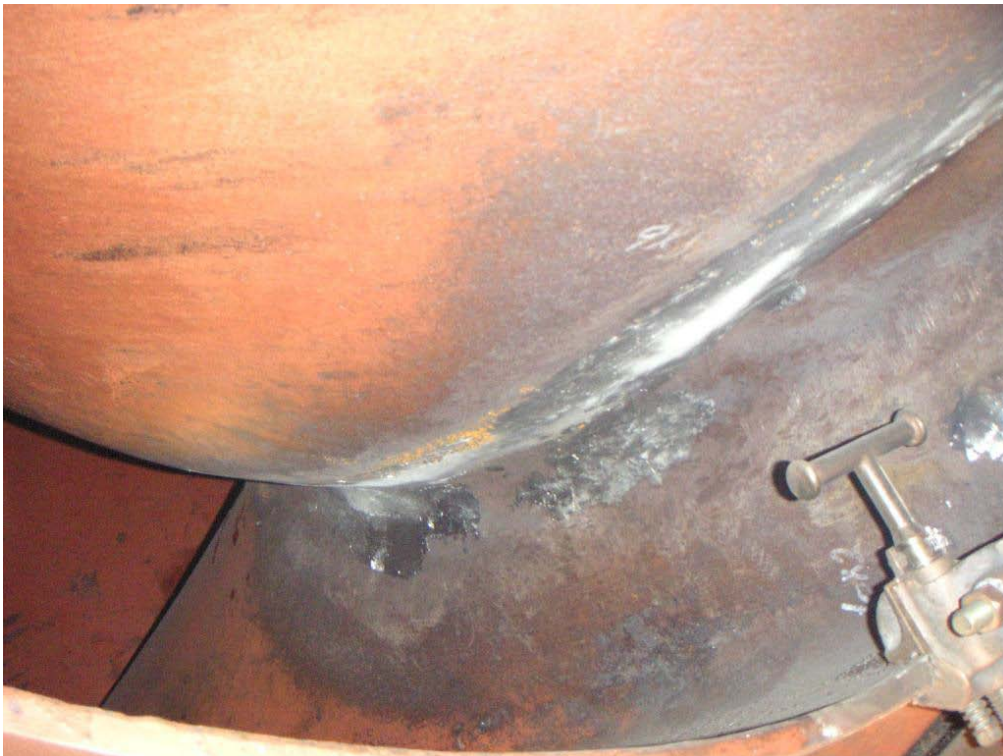
Figure 3. Typical cavitation damage area showing that cavitation-prone area covers much of area near fillet on suction side of buckets.

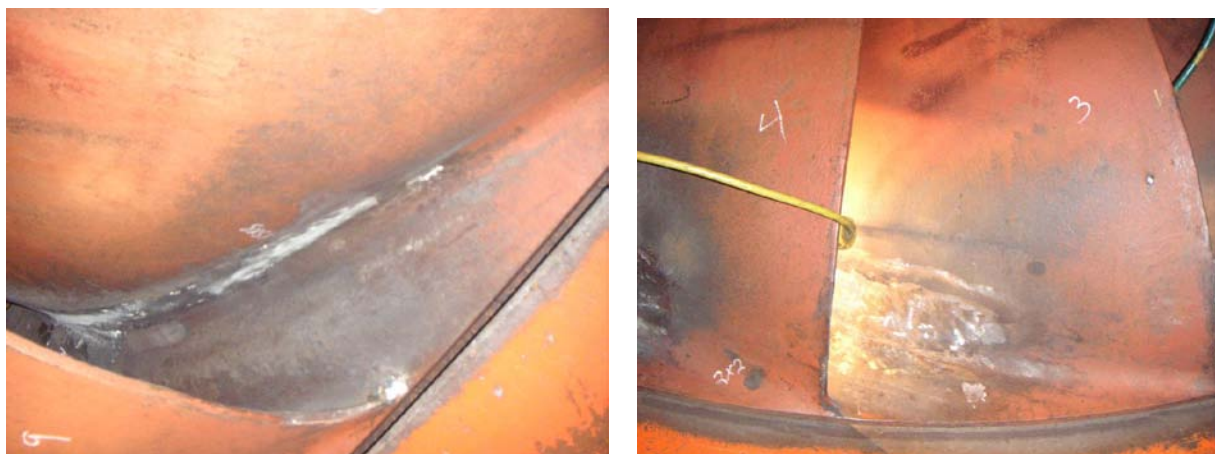
Figure 4. Typical cavitation repair areas on discharge side of buckets.
